Impacts of Sediment Loading and Siltation in the GBE

Fred Short, JEL, UNH

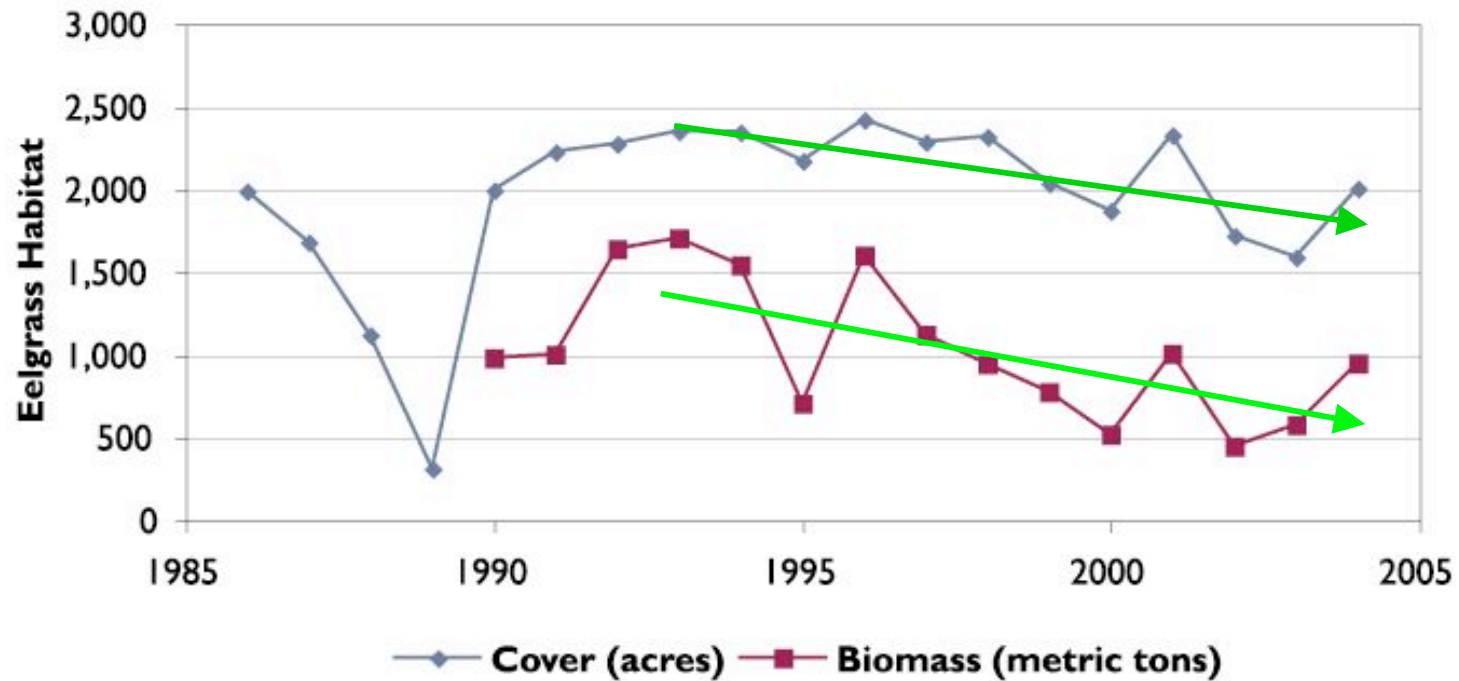
Monitoring Eelgrass cover and biomass in the Great Bay (Figure 17)

Data Source: UNH Seagrass Ecology Group

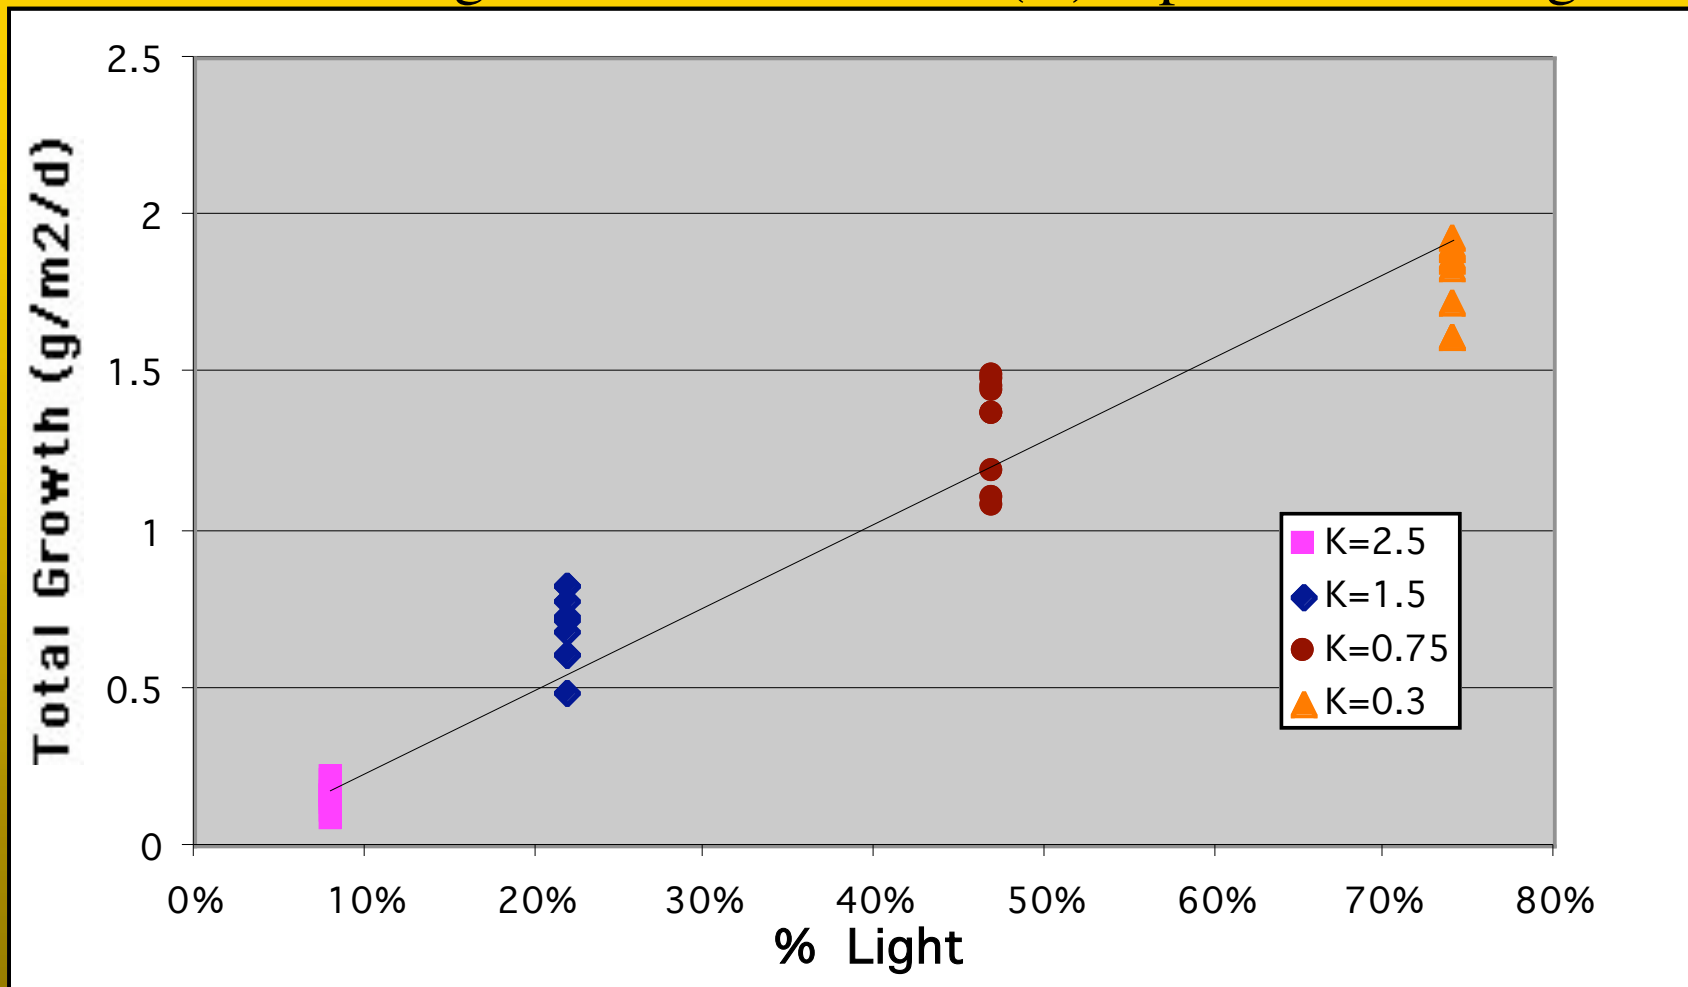
Eelgrass daily growth at 2 meters depth for 9 days in July with different light extinction values (K) replotted vs. % light.

Short, F.T., D.M. Burdick and J.E. Kaldy. 1995. Mesocosm experiments quantify the effects of eutrophication on eelgrass, *Zostera marina* L., Limnology and Oceanography 40:740-749

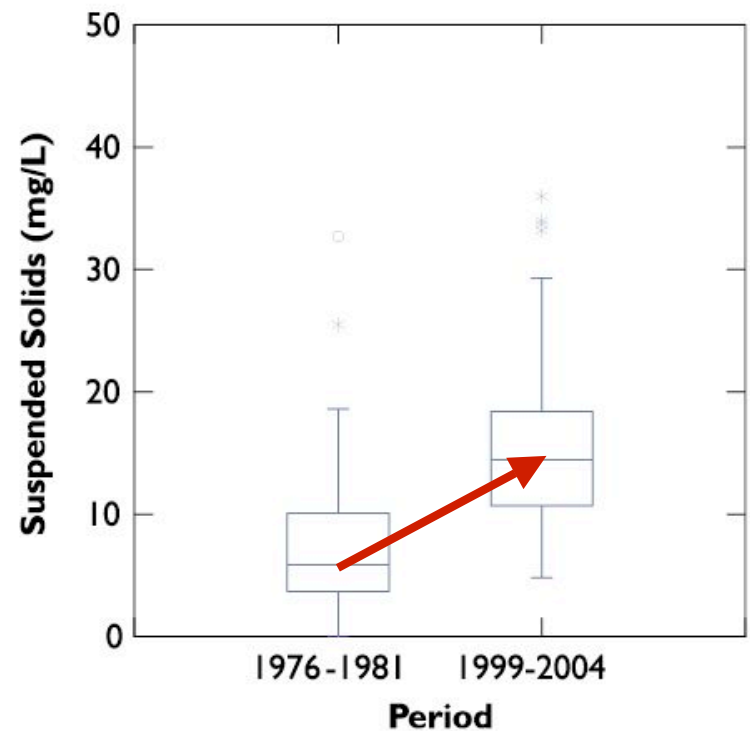
Suspended solids concentrations measured at Adams Point at low tide (Figure 7)

Data Source: UNH Jackson
Estuarine Laboratory

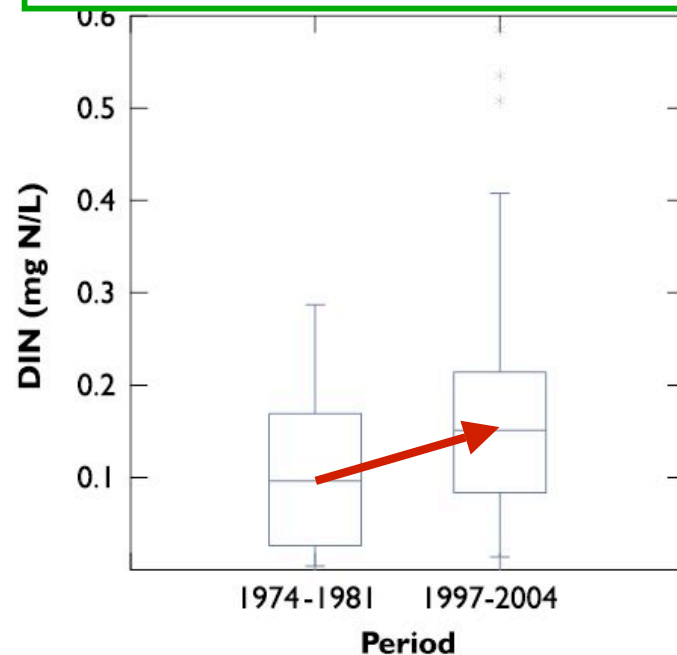
Dissolved inorganic nitrogen concentrations measured at Adams Point at low tide (Figure 6)

Data Source: UNH Jackson
Estuarine Laboratory

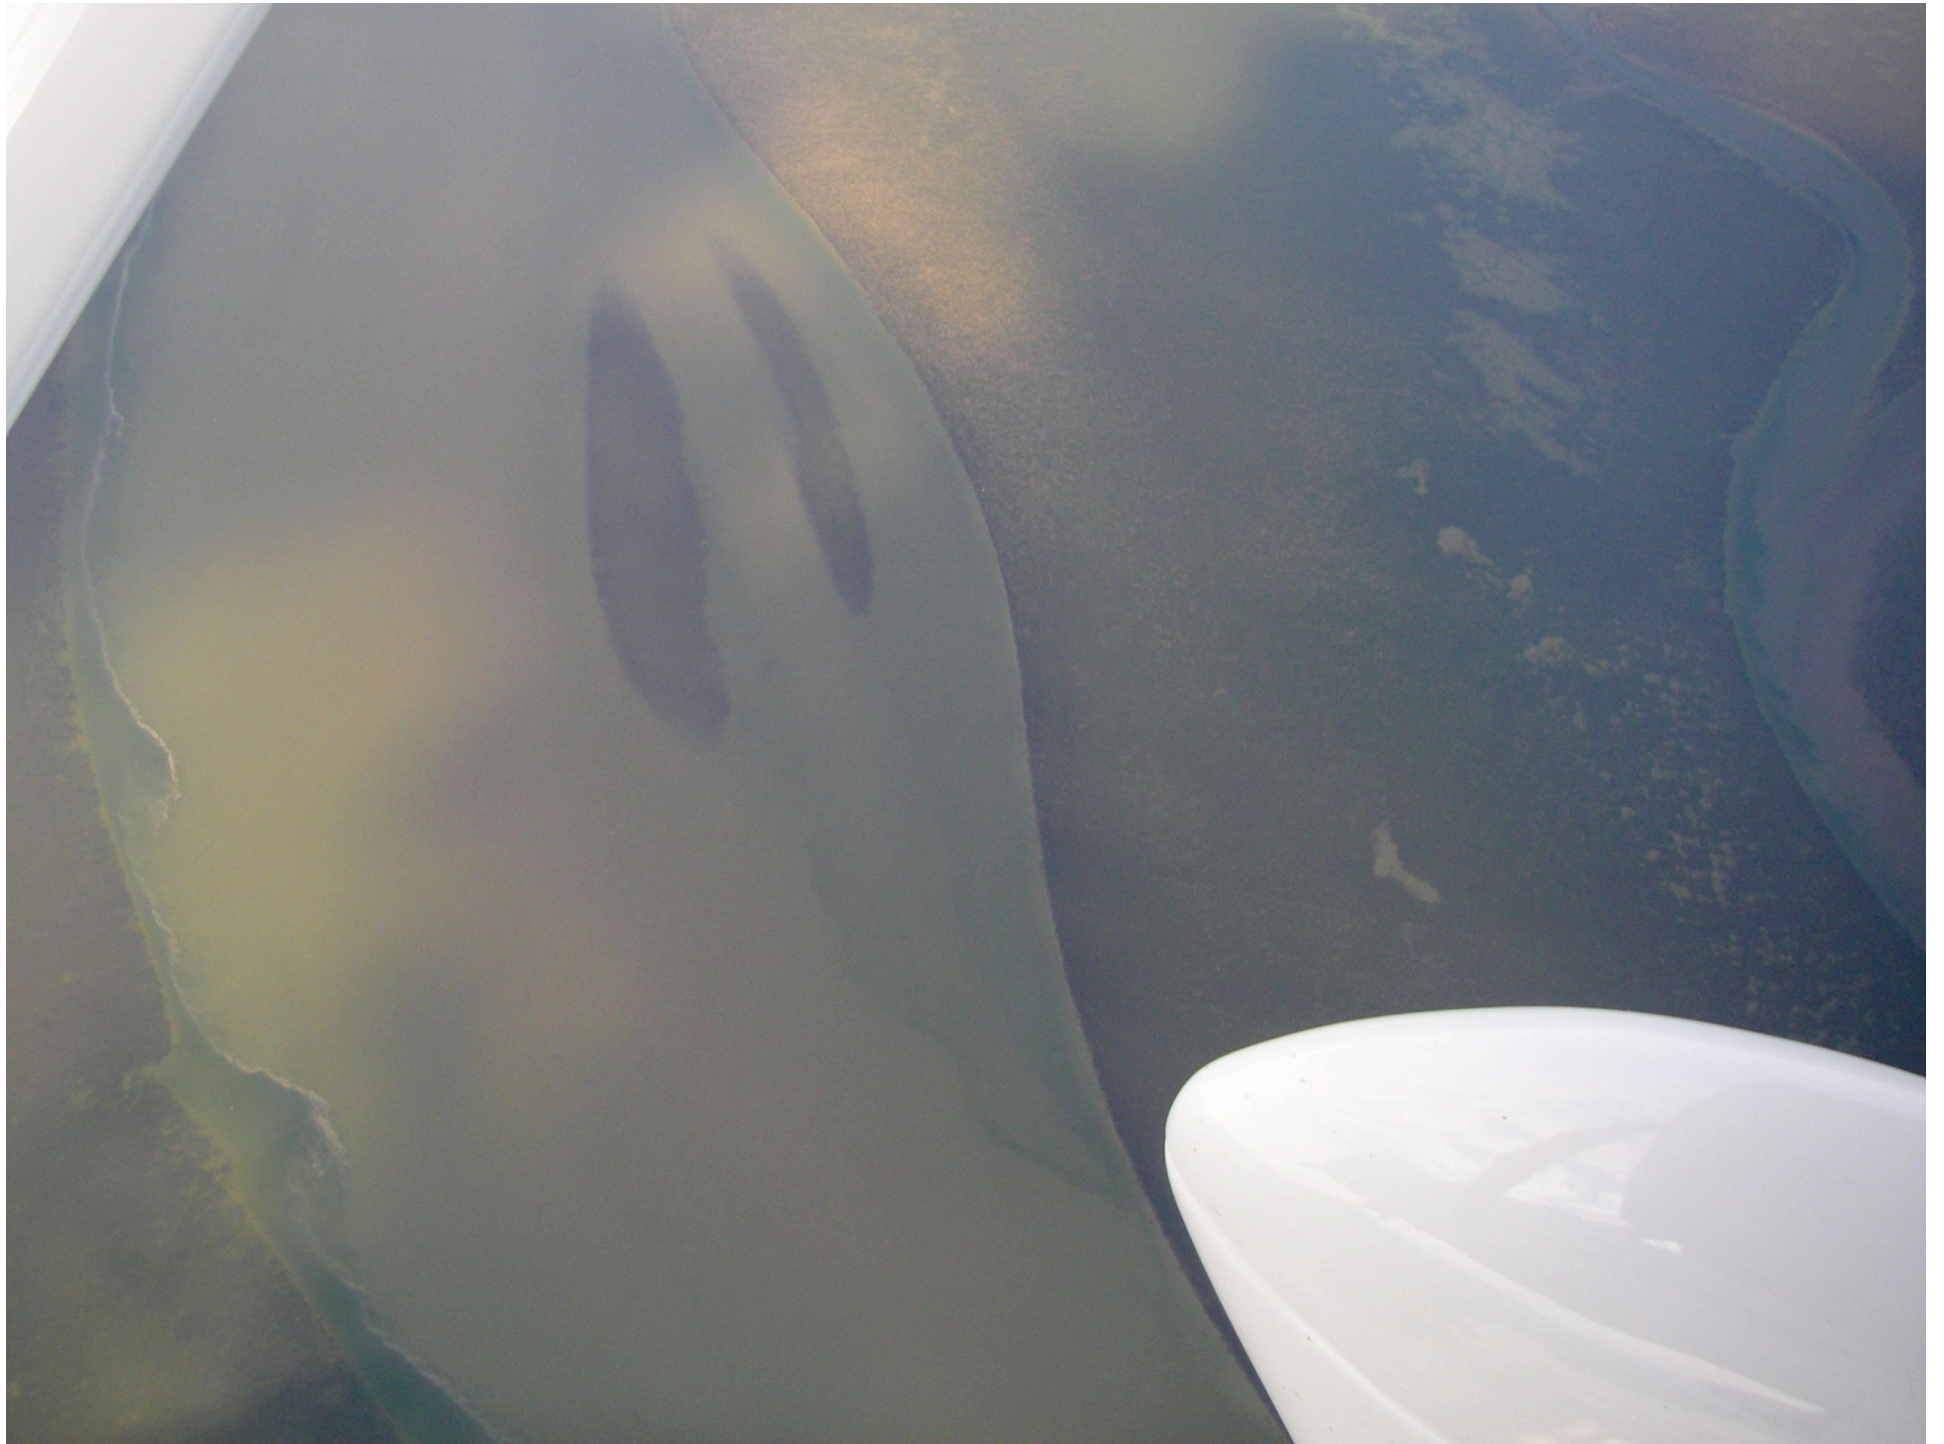
OYSTERS

Healthy

Squamscott River reef

Bellamy River dead oysters

Siltation

Nannie Island bed

Oyster River dead reef

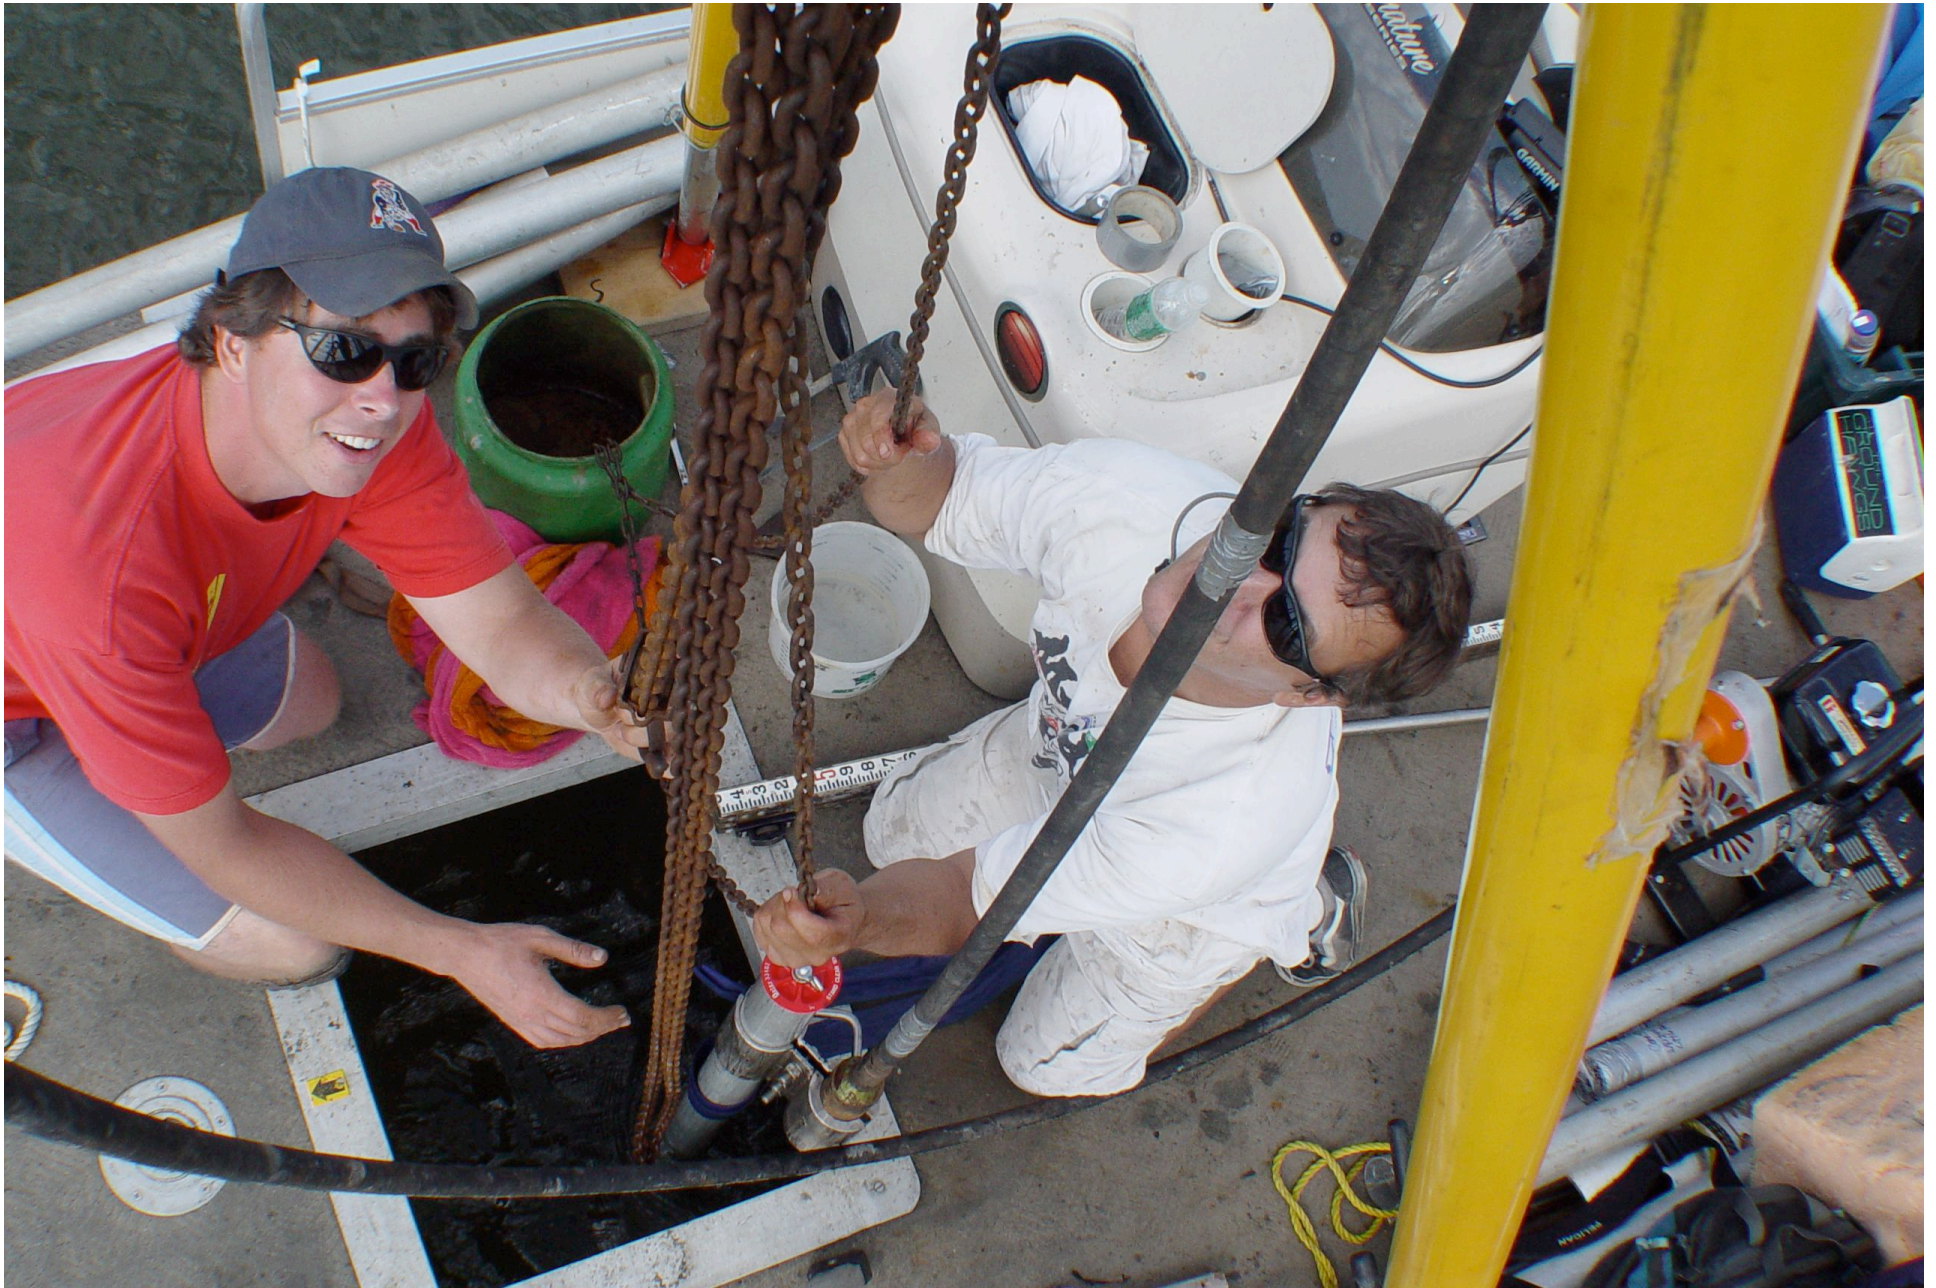
Fig 1. Donald Keirstead and Jim Turenne of USDA-NRCS extracting sediment cores from the Bellamy River with a standard Vibracore™ mounted to a shallow-draft pontoon boat. *Photo: Gregg Moore*

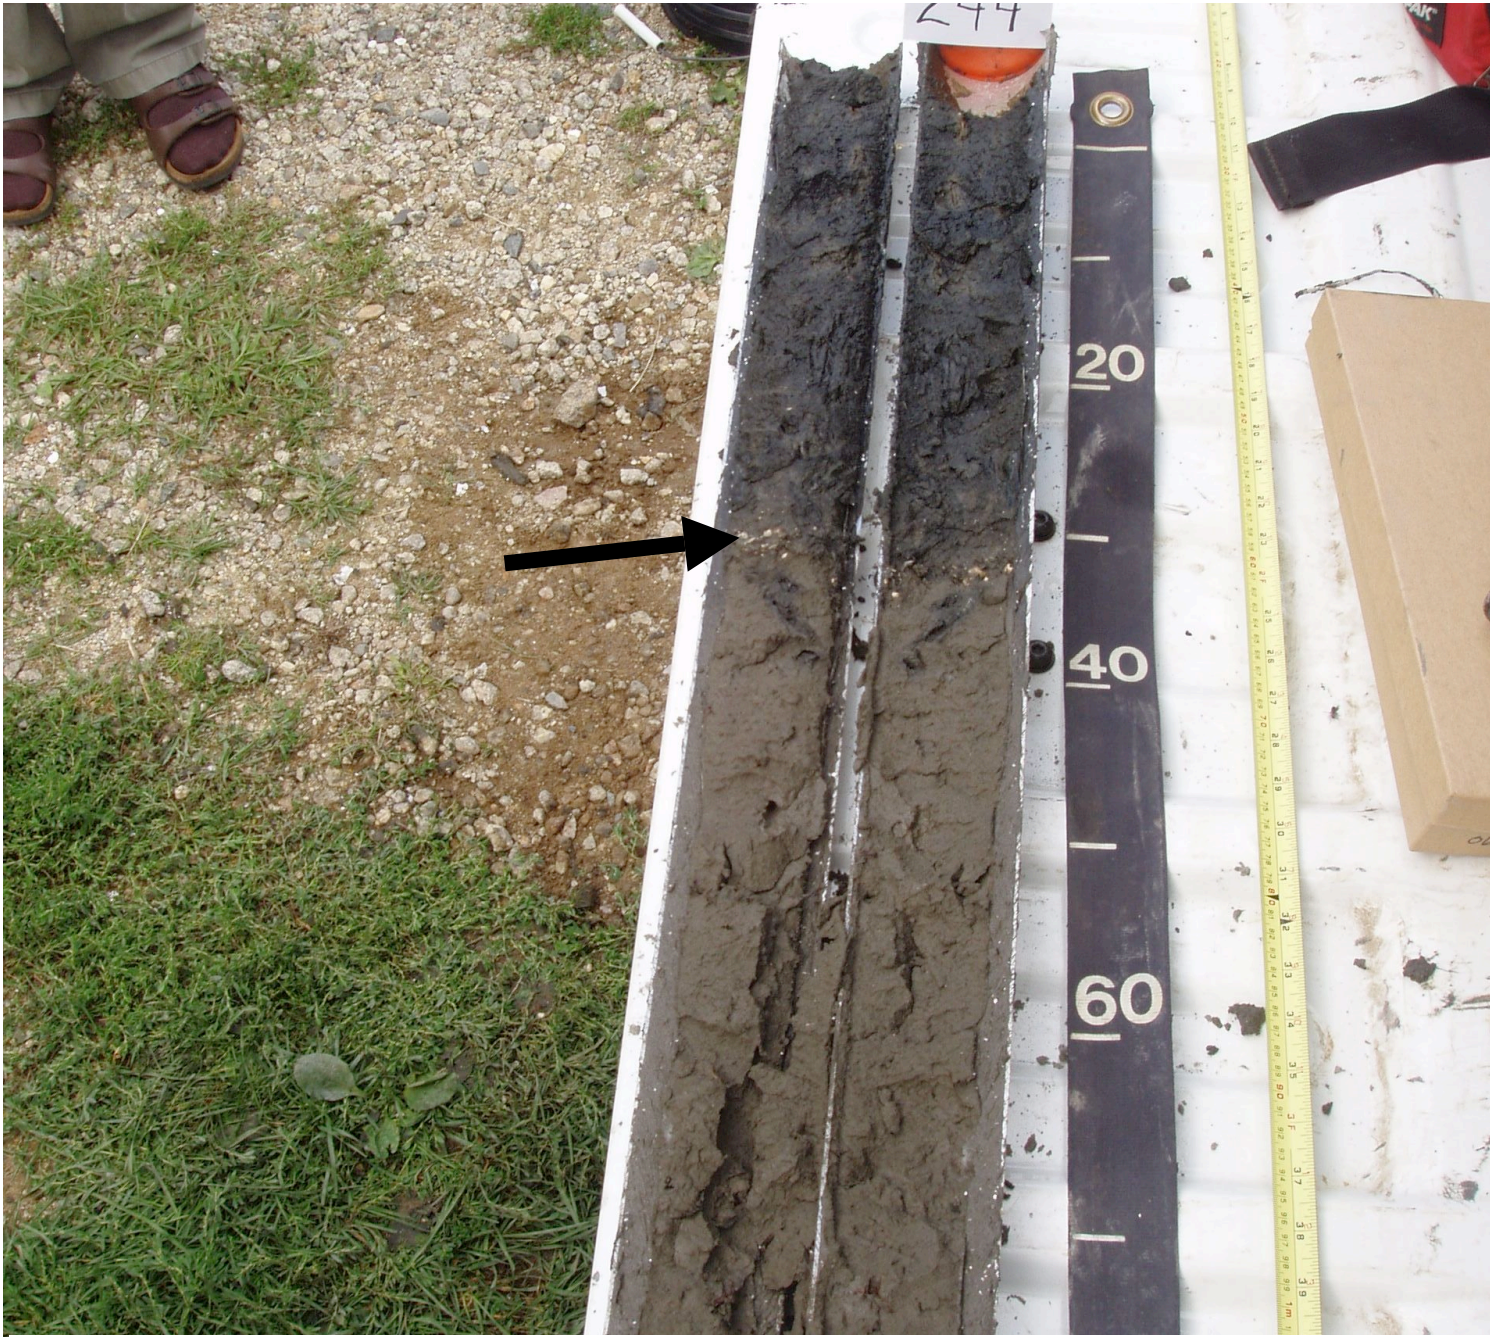
Fig 2. Cross section of sediment core sample from the Bellamy River. A buried shell layer is evident just below 30cm.
Photo: Donald Keirstead

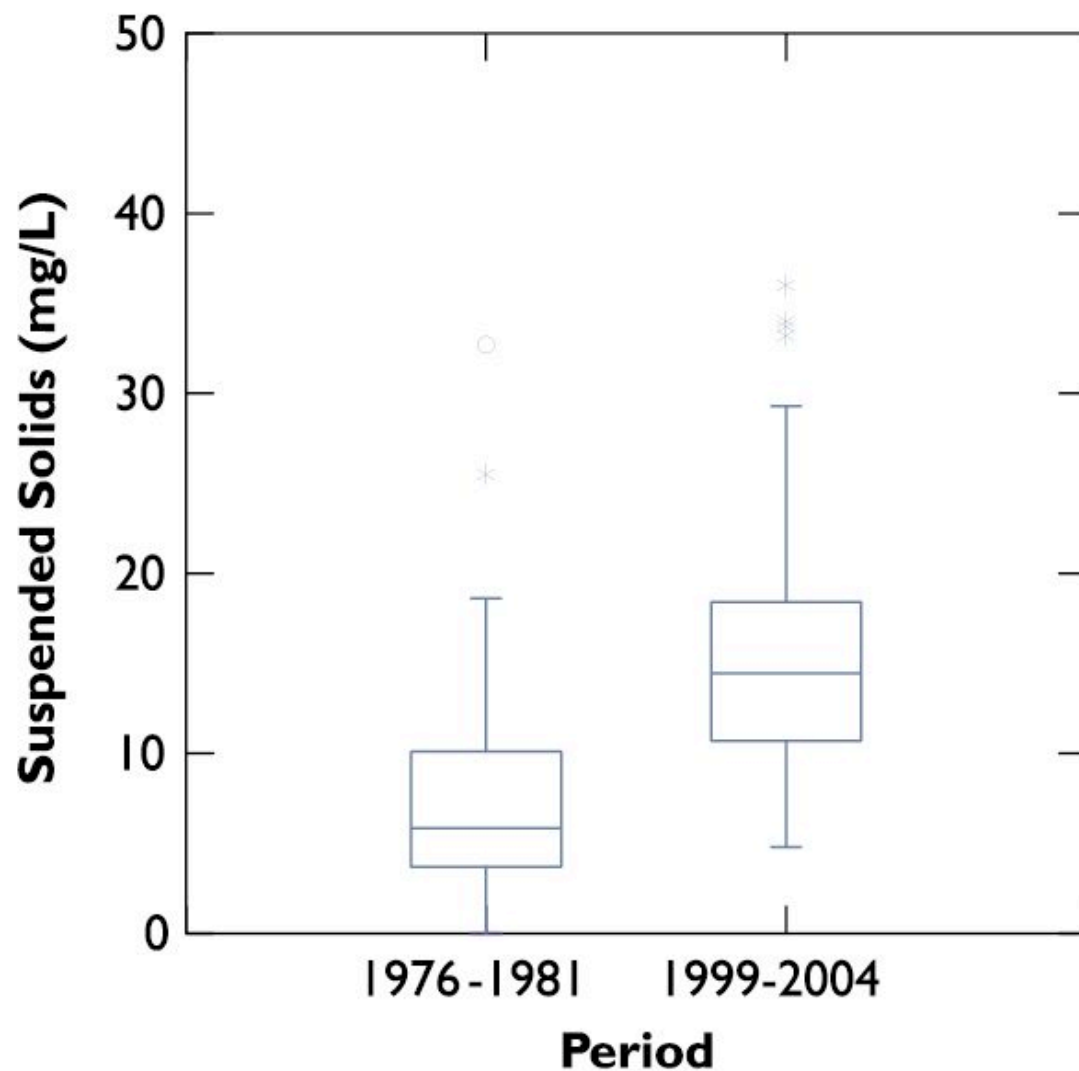
Suspended solids concentrations measured at Adams Point at low tide (Figure 7)

Data Source: UNH Jackson Estuarine Laboratory

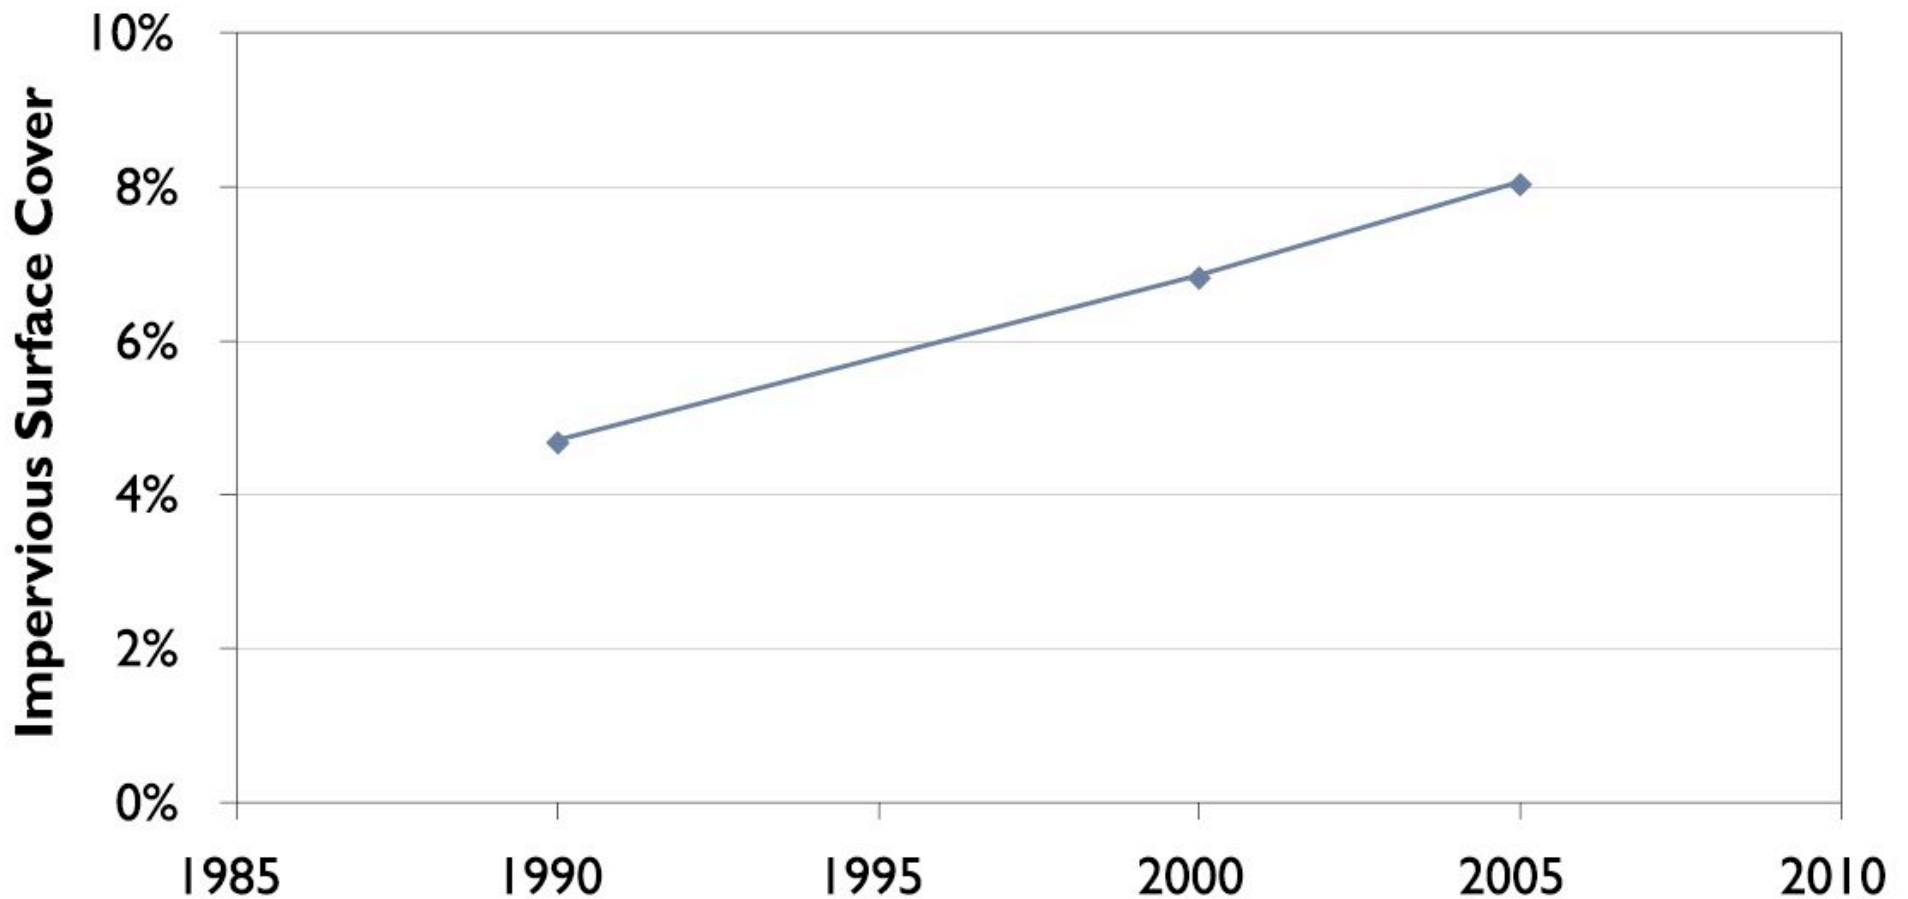
Percent of land area covered by impervious surfaces in the coastal watershed in 1990, 2000, and 2005 (Figure 19)

Data Source: UNH Complex Systems Research Center

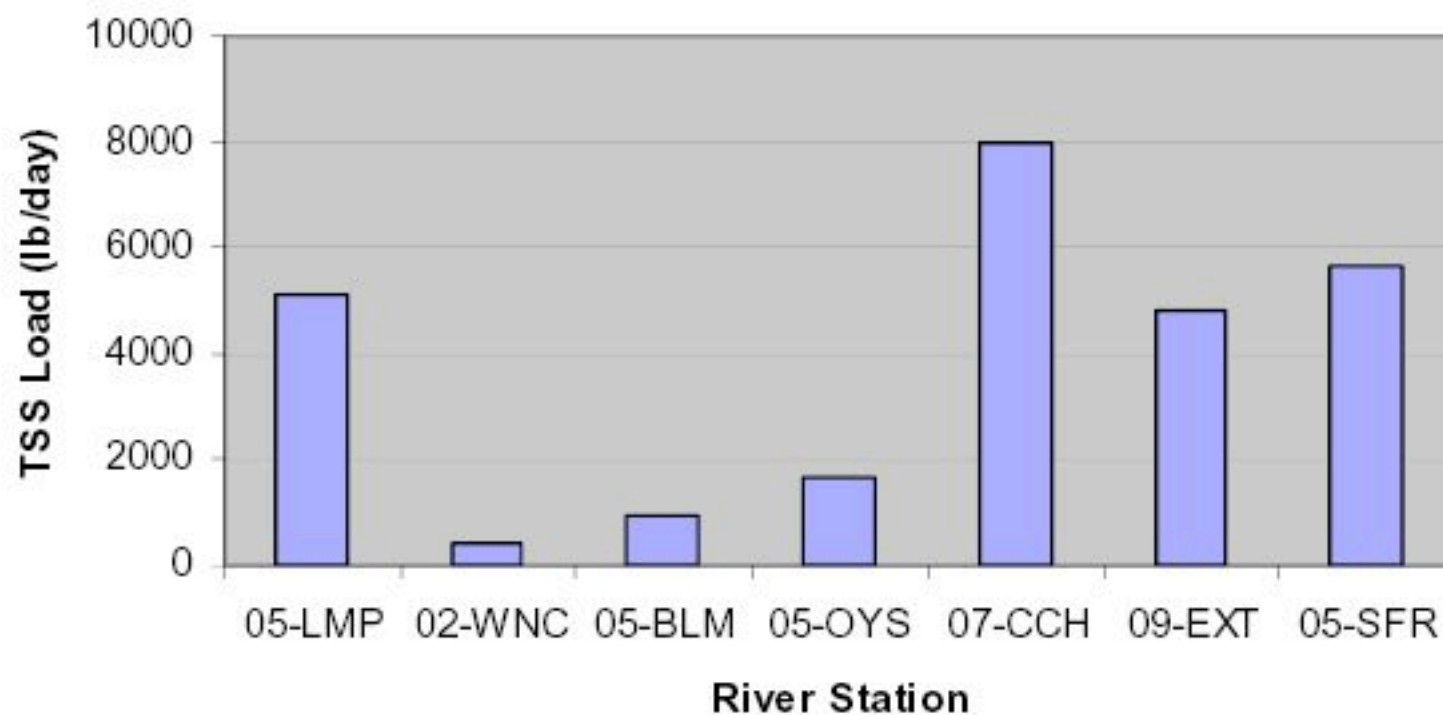
Sediment Loads from GB Tributaries (2002-2005)

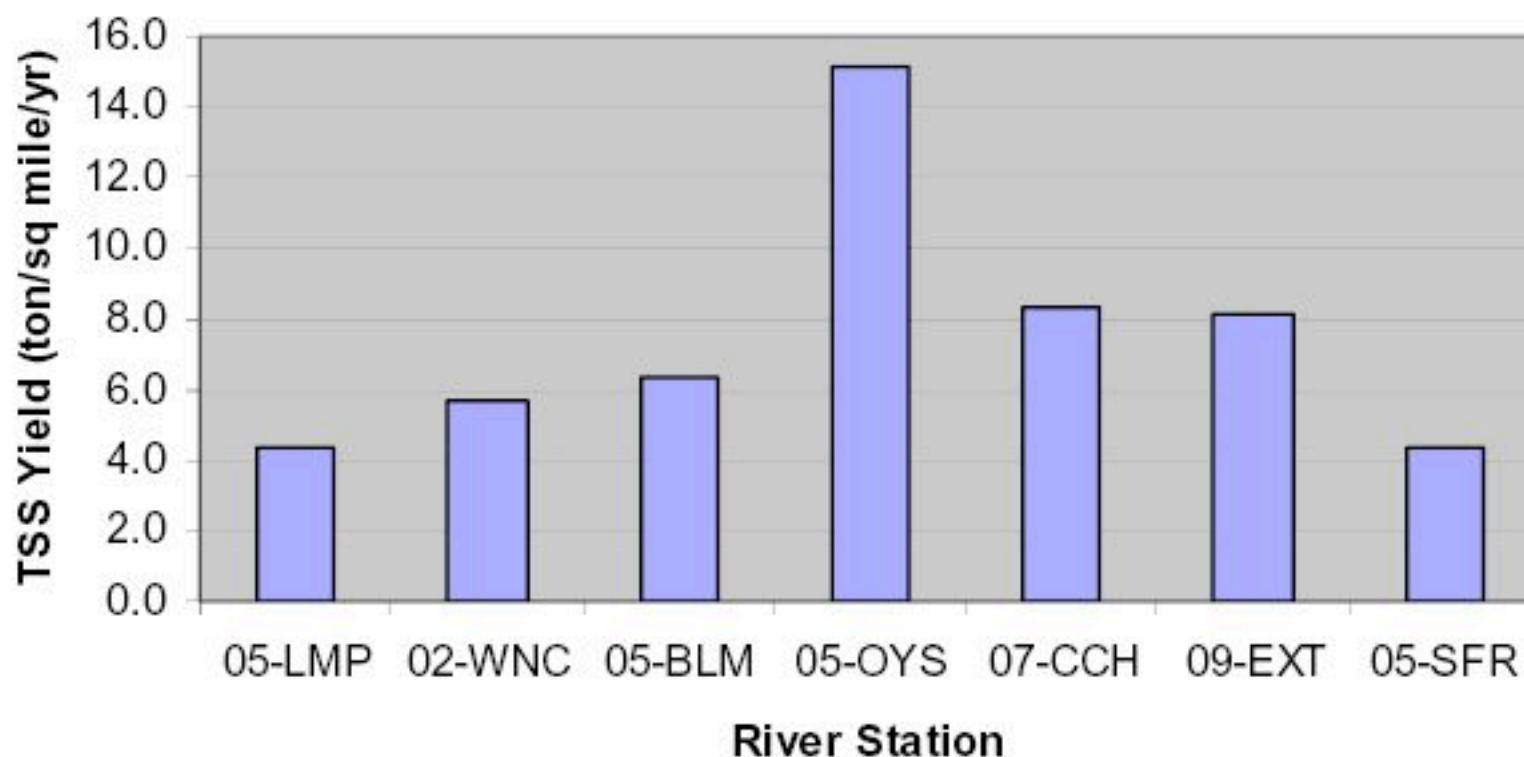
Sediment Yields from GB Tributaries (2002-2005)

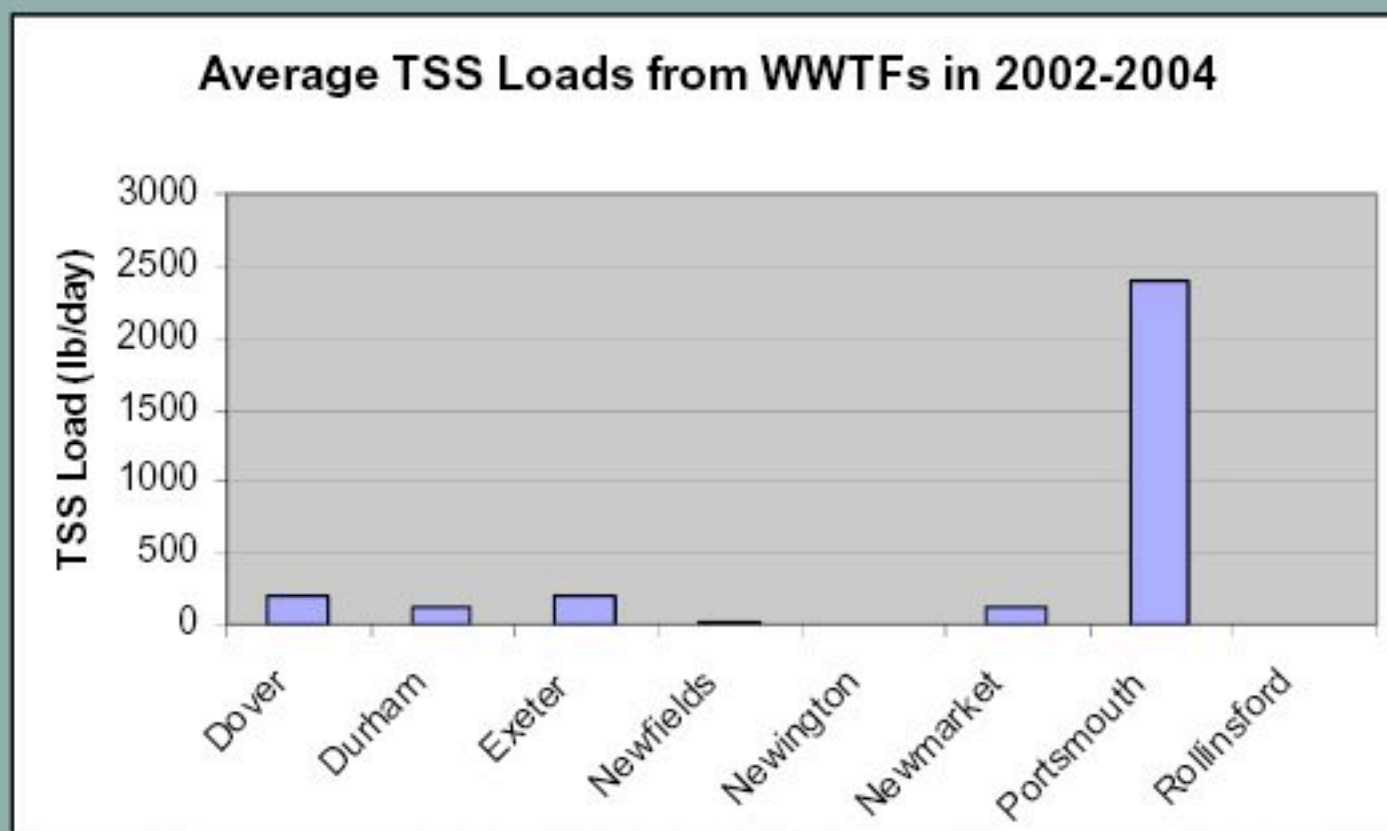
Sediment Loads from WWTFs

**Note: The measured load for the Cocheco River was 8,000 lb/day.
The WWTF loads are all much smaller than the river loads.**

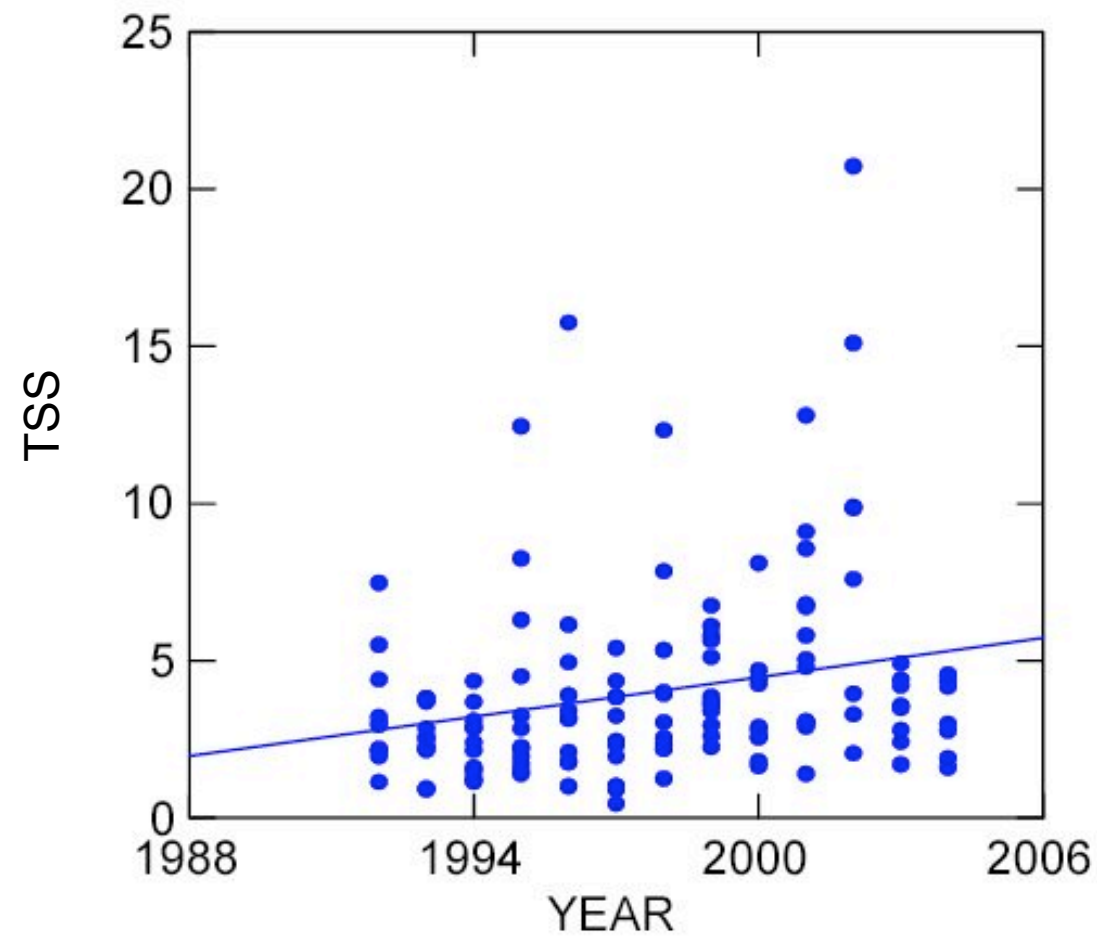
Total Suspended Solids

Statistically Significant Trends

$TSS = 0.209 * YEAR - 413$ Percent Change 1992-2004 = 76%

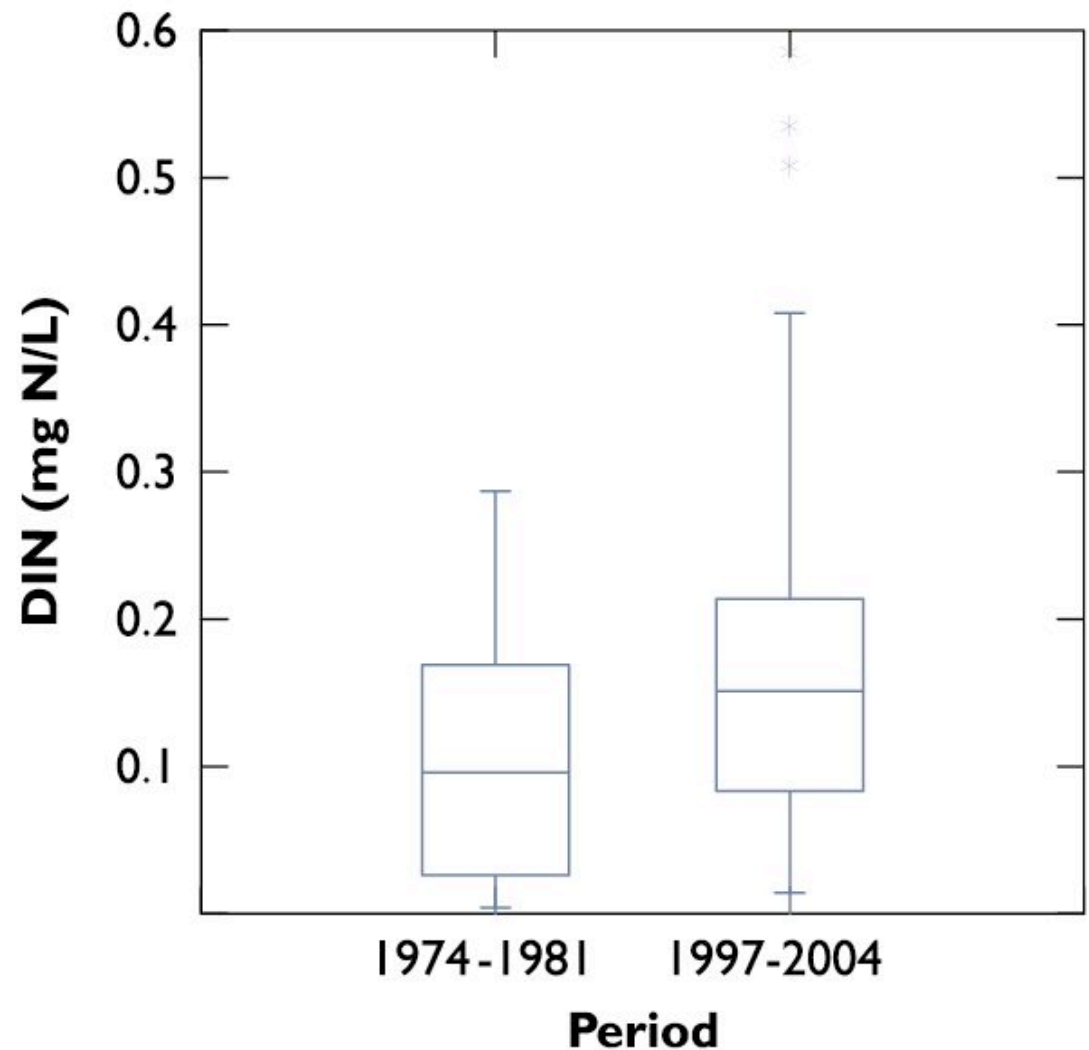
Dissolved inorganic nitrogen concentrations measured at Adams Point at low tide (Figure 6)

Data Source: UNH Jackson Estuarine Laboratory

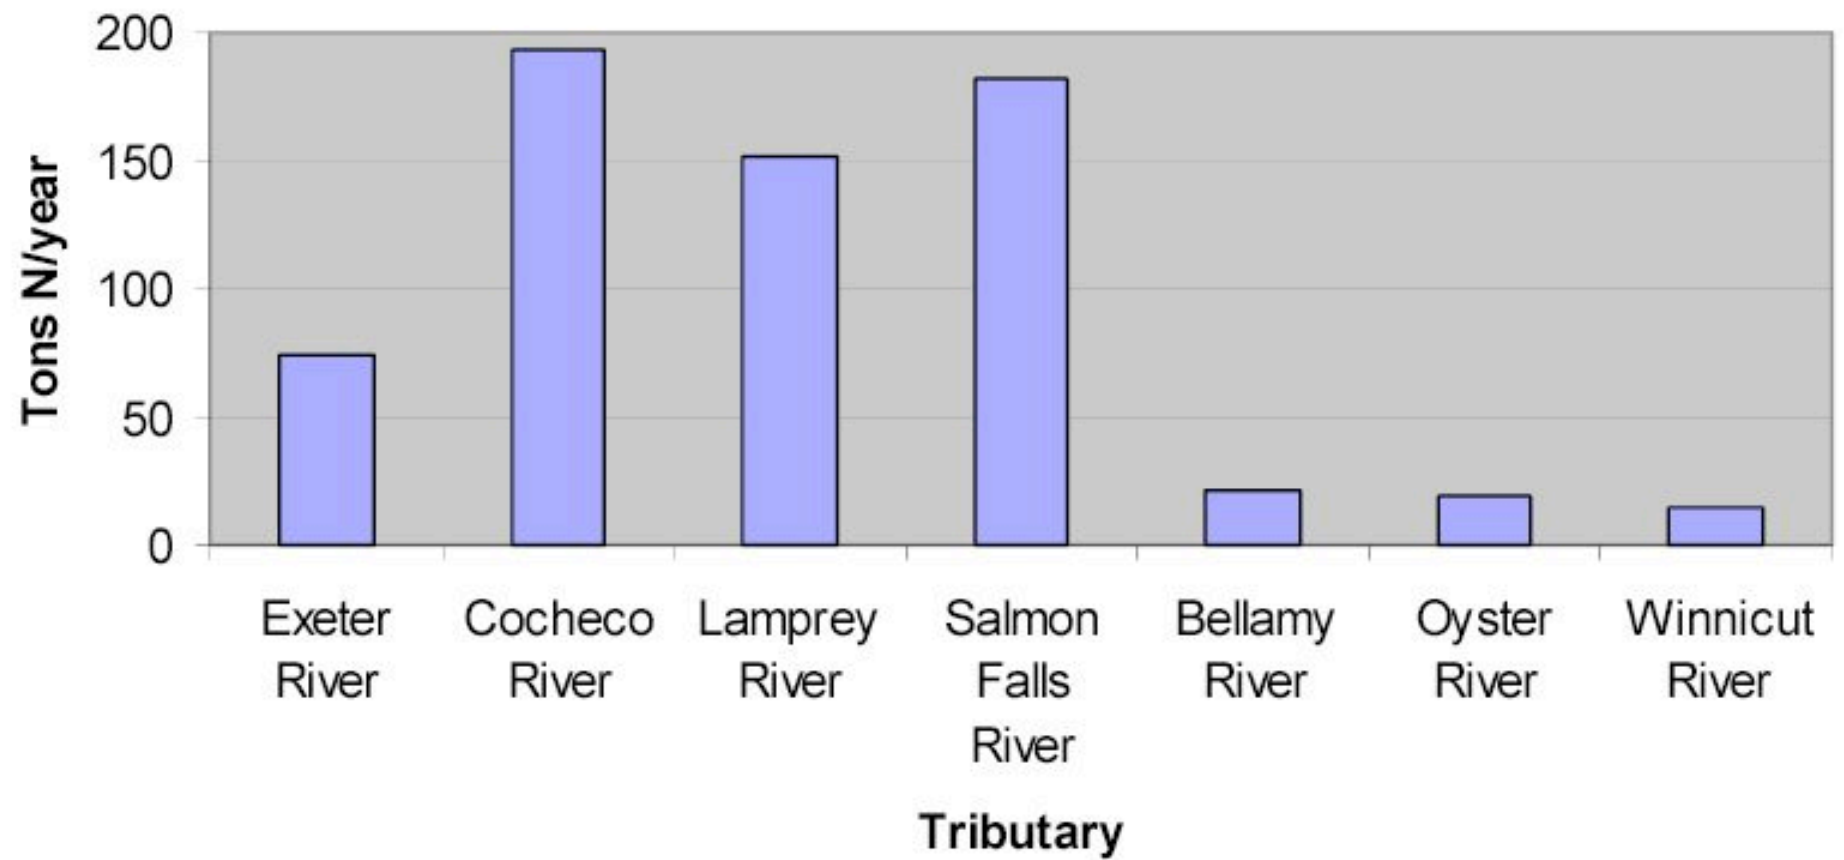
Total Nitrogen Load from Tributaries

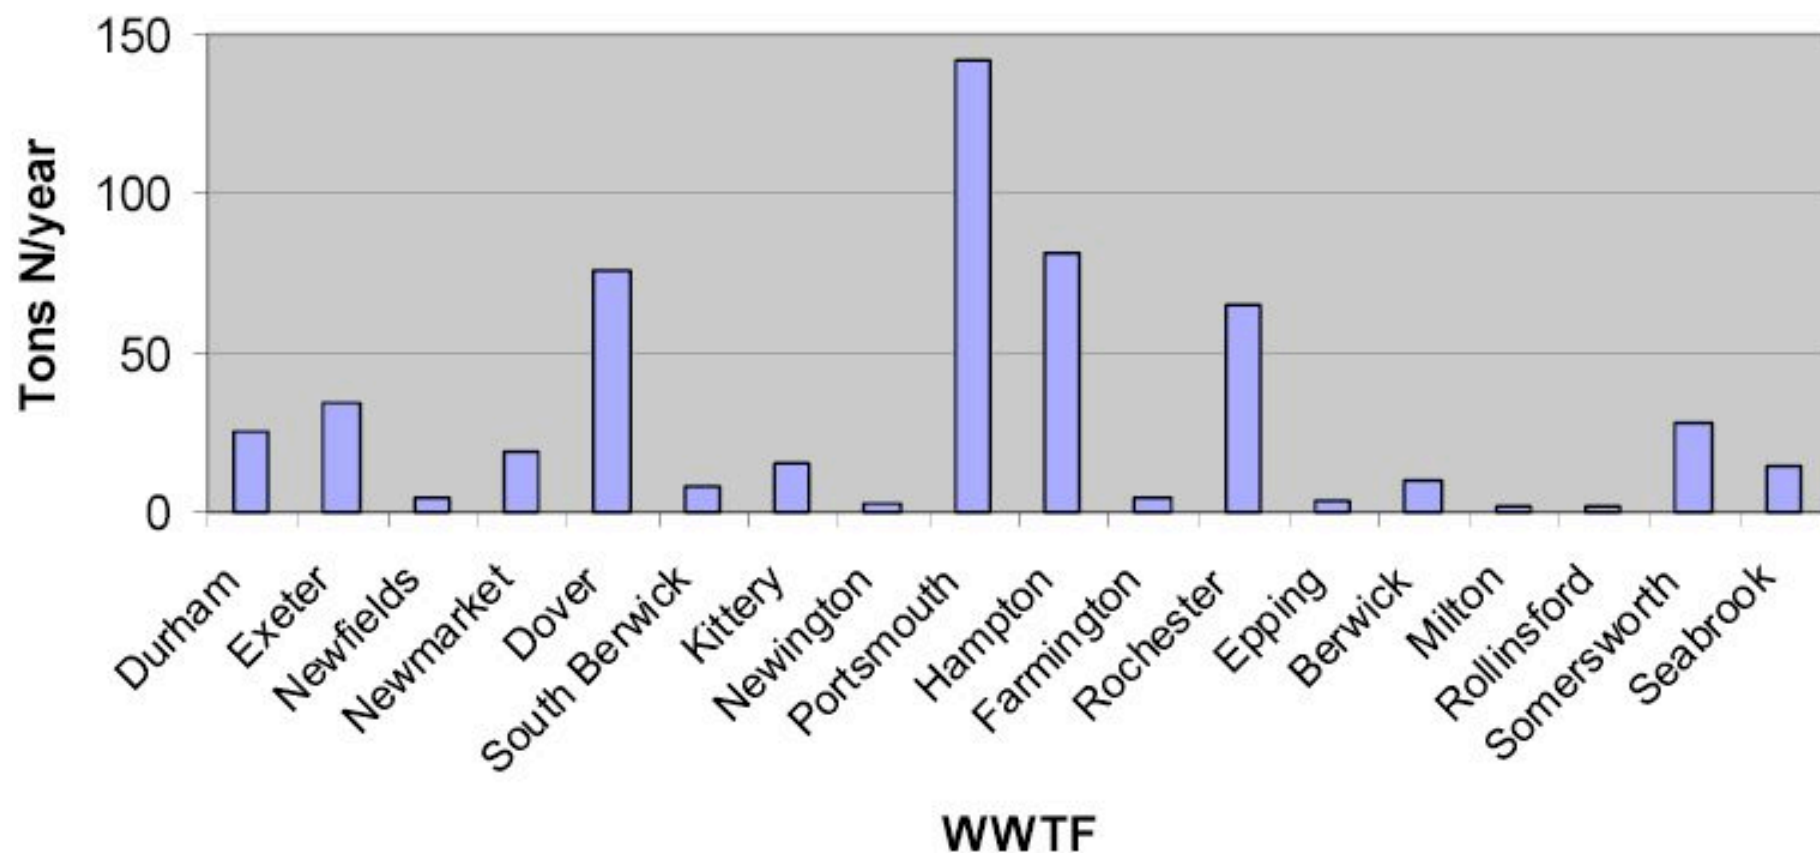
Total Nitrogen Load from Coastal WWTFs
